Arizona Home Inspections, LLC

Home Inspection Report

8341 N Willow Park Way
Tucson, AZ

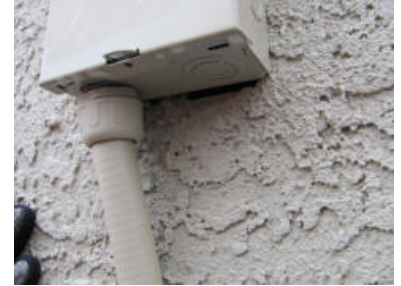
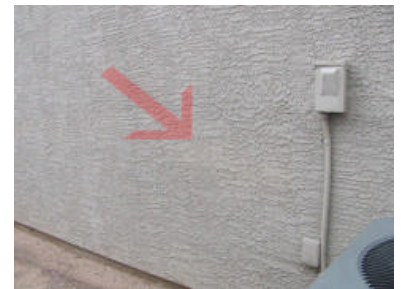
Repair: Minor cracks were noted in the exterior wall surface. The majority of the cracking was located at the corners of the window and door area. We recommend monitoring the cracks and repair as required.

Repair: The paint/finish at the exterior is incomplete or uneven at one or more areas (south wall west of ac unit). Attention to the paint/finish is recommended to maintain the appearance and design function of the exterior skin of the building.

Repair: The exterior wall surfaces were in need of caulking at all cracks, gaps, and openings (mainly at the ac disconnect box). Attention is recommended to guard against water intrusion, repair as necessary.

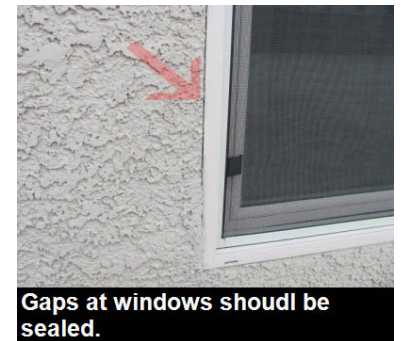
Repair: Caulking at the window/door perimeters is needed. Attention to the sealing of perimeters is recommended to keep out moisture intrusion and insects.

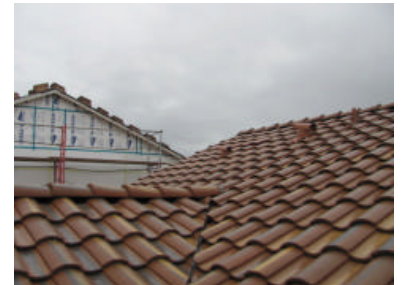
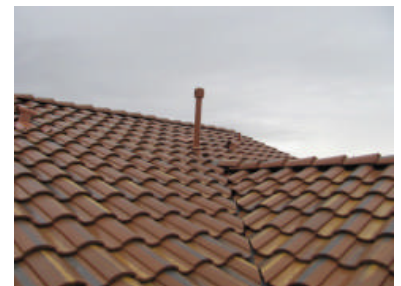
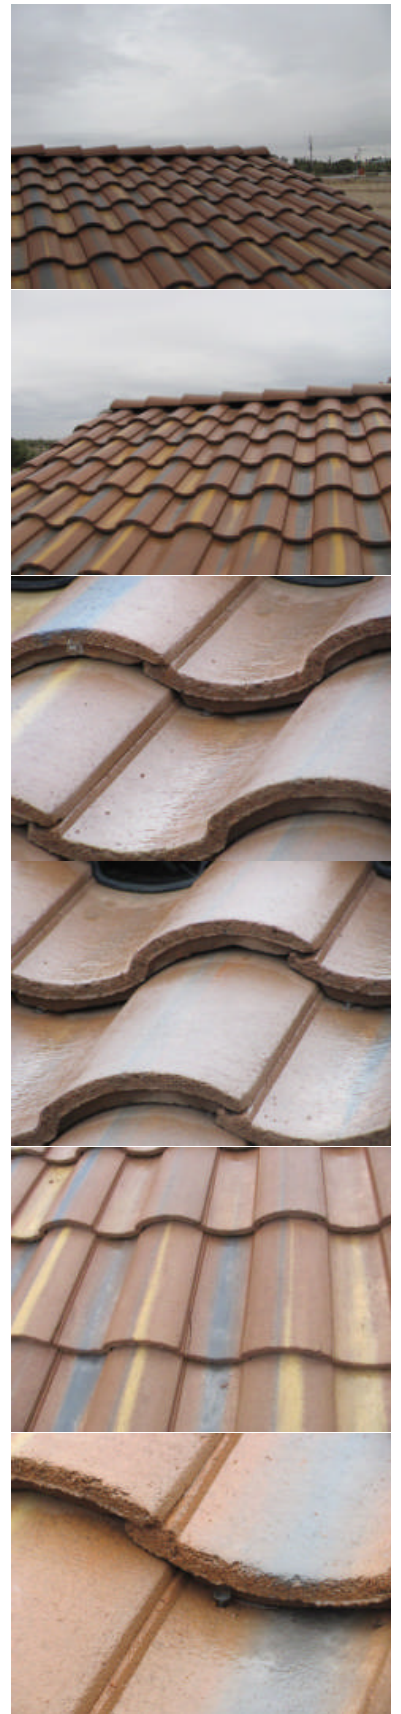
Repair: The roof has improperly installed tiles with exposed fasteners and inadequate Head Lap at multiple areas. This condition is common however can expedite underlayment deterioration and promote moisture damage. Recommend correcting the tile head lap or sealing the exposed areas as needed.

Repair: A spot check was made and found the roof tiles were without the proper perimeter nail fastening at one or more areas. Perimeter fastening areas for clay or concrete tiles include three courses but not less than 36 inches from either side of hips or ridges and edges of eaves and gable rakes. Improper fastening of the tiles may result in voiding any manufactures warranty.

Further Review: At least two cracked or damaged tiles were observed at the rooftop. Additional tiles or conditions may be found by a roofing professional. We recommend further review of the entire roof system for a better understanding of replacement costs/repairs and present condition.

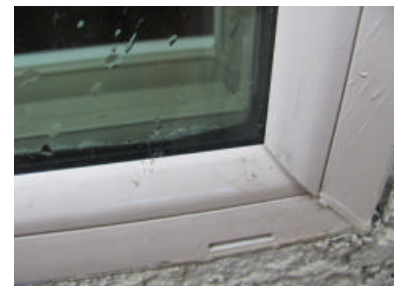
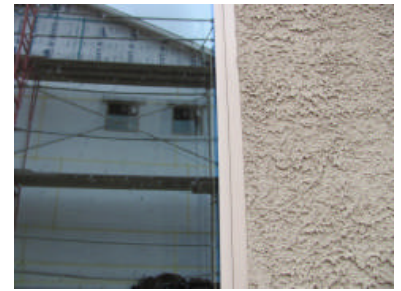
Repair: The window at the south bedroom presented symptoms early of a breach seal or failure between two pieces of glass and or defective window. This often takes the form of condensation between the panes of an insulated glass unit. We recommend full evaluation of all the windows by an appropriate person with replacement of all breeched windows.

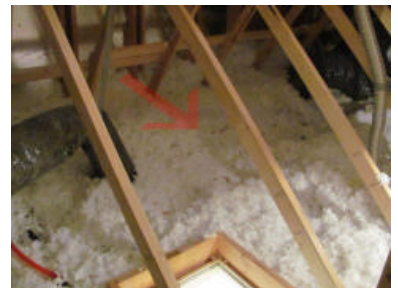
Repair: Insulation in the attic was compressed, by either stored personal items, traffic in the attic space, or installation of a finished surface. Compressing the insulation reduces its effective "R" value and is not recommended. Attention to the compacted insulation is required to receive the full benefits of the insulation present.

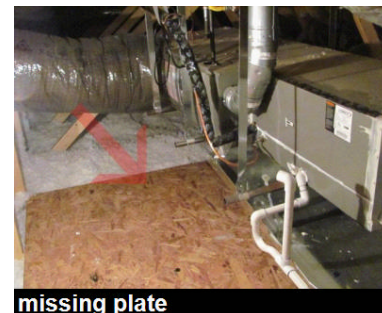
Repair: The furnace cabinet combustible fire barrier panel was missing at the attic service platform. We recommend that the proper barrier installed as required for the safe and proper operation of the unit.

missing plate
