Arizona Home Inspections, LLC

Home Inspection Report

8341 N Willow Park Way
Tucson, AZ

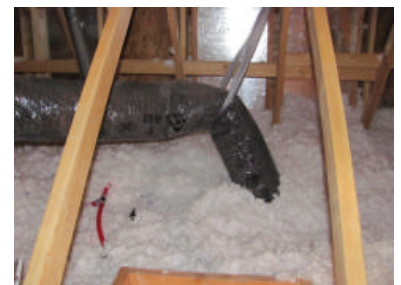
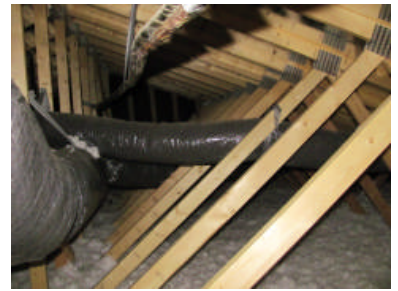
1. Attic Location And Access

The attic access panel was in the ceiling of the master bedroom closet.

The inspector had limited access to the attic. Because of limited clearances and/or the potential for damage, our visual inspection of the attic was performed from the reasonably accessible areas only.

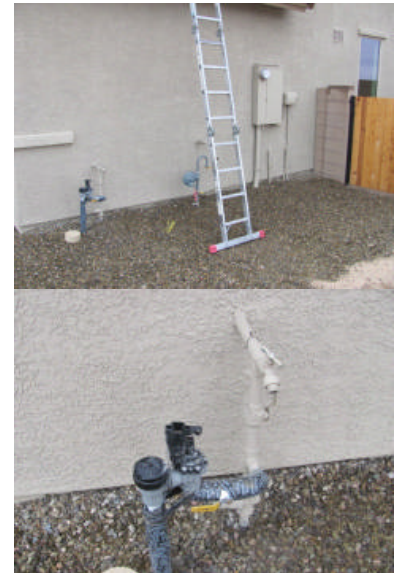
The water pressure for the building, measured at an outside hose bibb was 45-50psi.

A domestic water supply main shut-off valve was outside at the front of the building. The main water supply line was fitted with an inline pressure regulator valve. This valve is adjustable so that the pressure can be regulated to a desired output generally below 80psi and above 45psi. The building's main water shut off valve was operated using normal hand pressure. Operation of the valve from time to time should keep it functional and maximize its useful life.

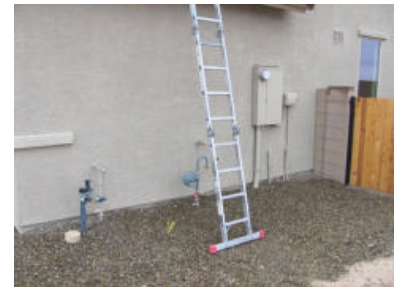
5. Gas System Piping

A bonding wire was present at the building side of the gas meter pipe. No natural gas meter or other type of gas piping was found on this property.

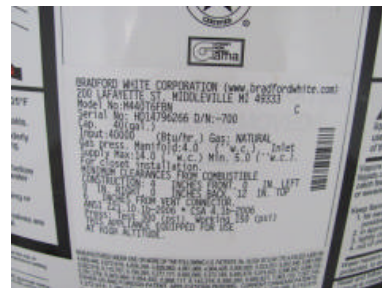
The location of the water heater was in the garage. The energy source for the water heater was natural gas and the storage capacity of the tank was 40 gallons.

The water heater appears to be the original unit installed at the time of construction. The name of the manufacturer or the brand name of this unit was Bradford White.

Further Review: The water heater inspection was limited due to the absence of a power source. The gas to the water heater was not on at the time of the inspection. We recommend further review for a better understanding of present condition.

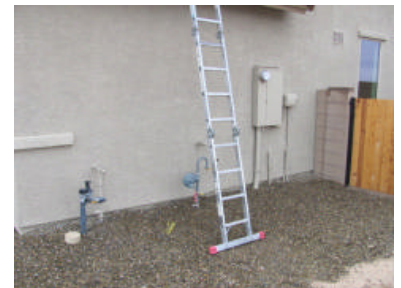
1. Service Entrance

The service entrance which supplies the power to the building's main electrical service panel was an underground (buried) lateral type service. As such, most of the main service lateral was not visible for inspection.

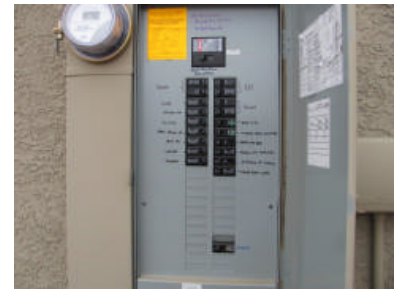
2. Meter - Main Panel

The electric meter and exterior main panel were observed to be in satisfactory condition and securely attached. The electric meter and main panel were located on the building's exterior right side.
